LDEF M&D SIG SUPPORT

Final Report

THE MAGNITUDE OF IMPACT DAMAGE ON LDEF MATERIALS

Martha Allbrooks and Dale Atkinson  
POD Associates, Inc.  
2309 Renard Place, S.E.  
Suite 201  
Albuquerque, New Mexico 87106

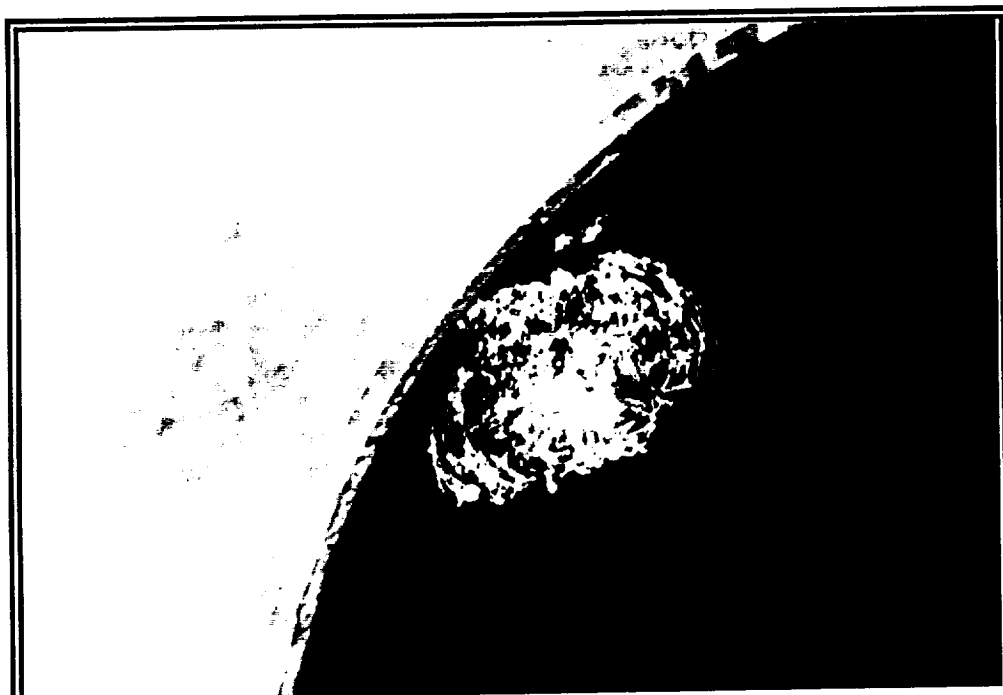
**Figure P2-41.** Photograph of an impact feature in an infrared (IR) multi-layer filter material on top of a germanium substrate.

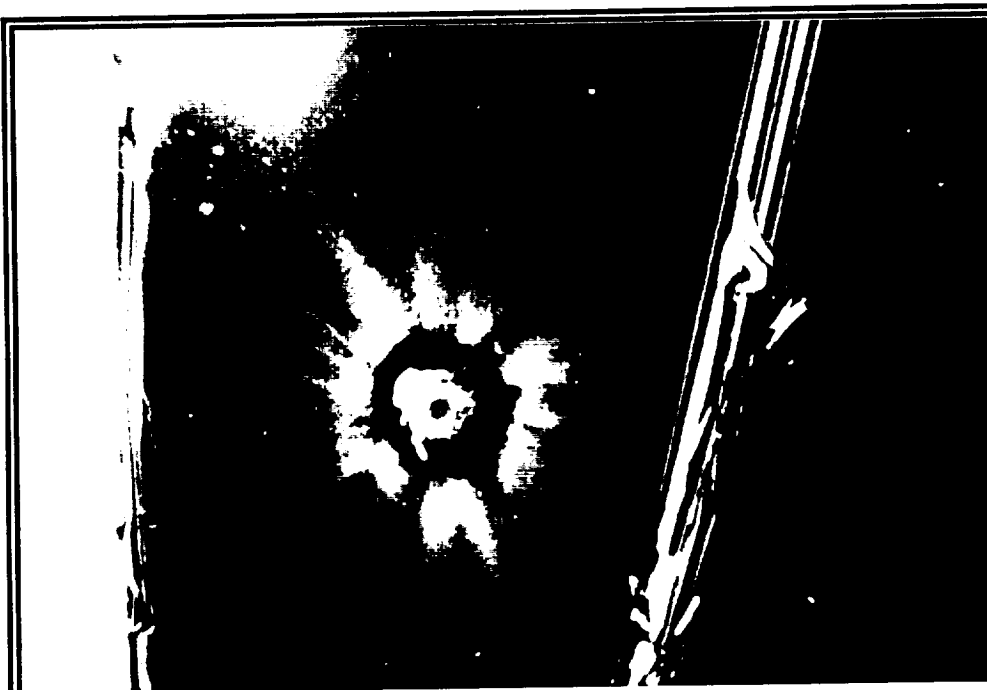
Figure P2-54. Photograph of ejecta spray onto a germanium substrate on experiment A0187-2.
